4.2 Upper Paint Branch Special Protection Area

4.2.1 SPA Designation History for the Upper Paint Branch SPA

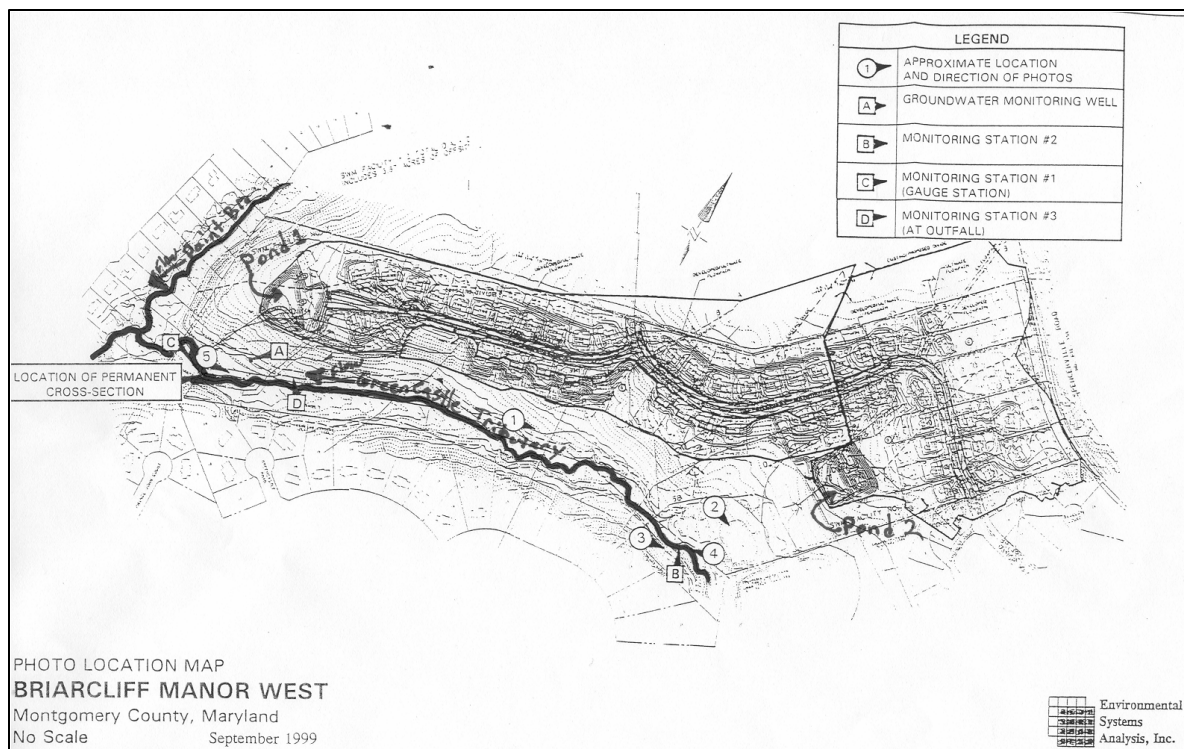
Figure 25 Map of Briarcliff Manor West and Associated Sediment / Stormwater Management Ponds.

Figure 25 is a map of the site. In 2002 DEP received information on stream temperatures, groundwater levels, stream flows and a channel cross section survey. DEP was unable to use groundwater data from the site in 2001 because of quality control considerations. Groundwater data from 2002 is plotted in Figure 26. Groundwater levels during 2002 were fairly similar to levels during the six corresponding months in 1999 for which we have pre-construction readings. This indicates that the well maintains very stable levels even during extreme drought periods. Its location low on the site, close to the stream probably explains that. At this point, development of the site does not appear to have impacted the stability of groundwater levels here and indicates that stream baseflows should not have been greatly impacted by development of the site. However, as DEP was only able to directly compare data for two six month periods, this is a very preliminary result. DEP will reassess this conclusion as new data comes

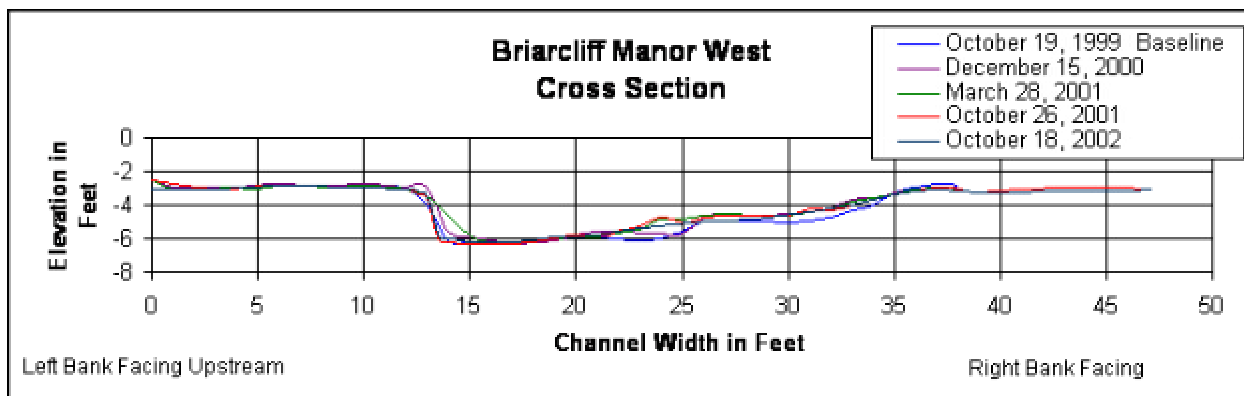
Figure 27 Briarcliff Cross Section

Channel cross section surveys show that the channel is somewhat dynamic but generally stable (Figure 27). At this time, development of the site does not appear to have caused channel instability at the cross section.

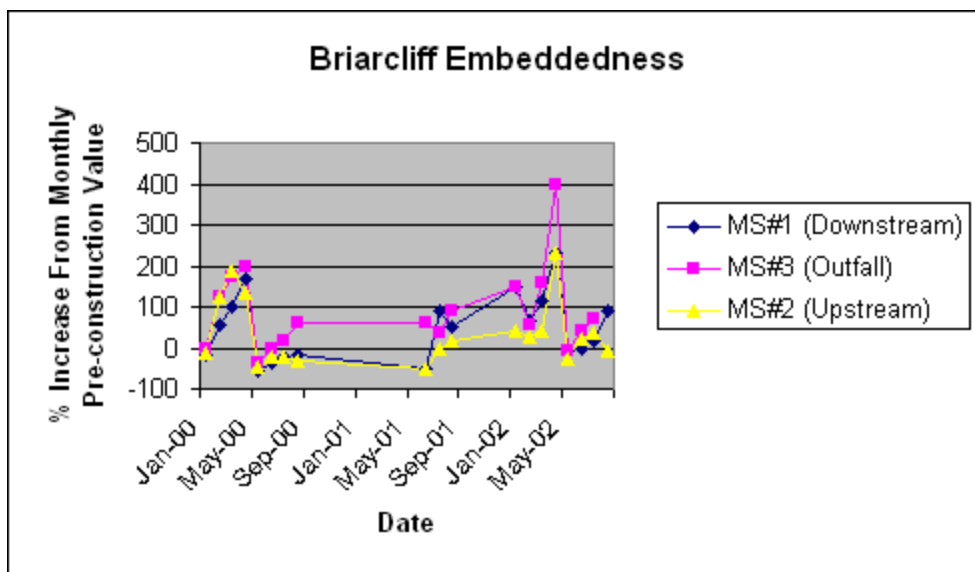
Figure 28 Briarcliff Embeddedness

Briarcliff embeddedness data is plotted in Figure 28. The data indicate that the stream has seen increased percentages of embeddedness at all three sample sites since pre-construction. This may be due to weather conditions, changes in the watershed upstream from Briarcliff or error in the data set. The data also indicate that embeddedness has increased far more at the outfall (MS#3) than it did at the upstream (MS#2) site. This effect is observed beginning in late 2000 and continuing on into early 2002. This increase was much less pronounced at the downstream MS#1 site. This may reflect the stage of development at the site or BMP maintenance status. The consultant's draft final report on construction conditions examines this in greater detail. The final version of their report is expected in Fall of 2003.

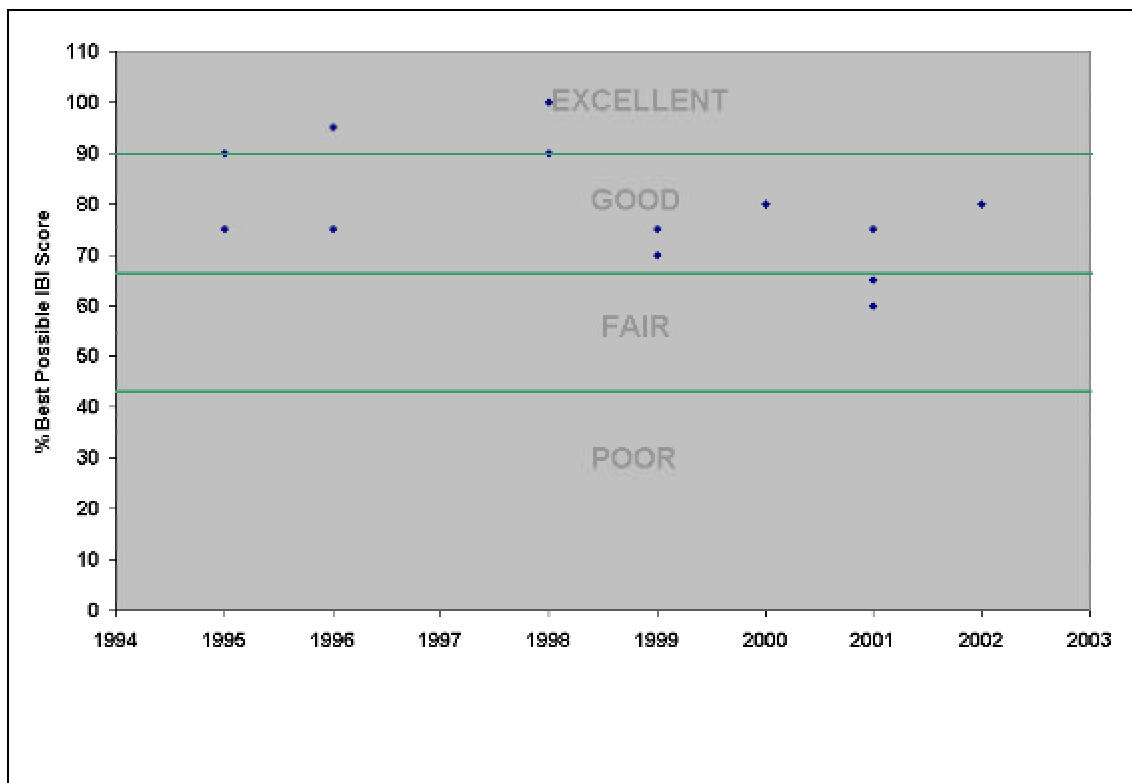
Figure 33 Benthic Macroinvertebrate Monitoring Results From Three Stations In The Right Fork – PBRF117, PBRF118, PBRF204. Two or one point(s) appear on the plot when two or three monitoring stations received the same IBI score

Two development projects within the Right Fork drainage area were completed during 2001, Fairland Community Center and Briarcliff Manor. Both of these projects have been fully stabilized and the sediment control traps/ponds have been converted to storm water management facilities. Biological monitoring at two stations (PBRF118, PBRF204) located directly downstream of these two development projects indicates slightly improved ecological health between 2001 and 2002. All results of benthic macroinvertebrate monitoring since 1995 from Right Fork stations are plotted in Figure 33.

The steady decline in IBI scores reported in last years SPA annual report did not continue into 2002. Last year we included a regression line that illustrated the downward trend in benthic IBI. This year no statistically significant regression line can be drawn through the data. Regression analysis does not

support statements regarding an ongoing linear decline in benthic IBI from 1995 through 2002. Although it appears that the decline has leveled off, benthic IBIs remain low in the right fork of Paint Branch. Benthic IBIs from 1995 through 1998 averaged 87 points. From 1999 through 2002 benthic IBIs averaged 75 points. A t-test (Figure 34) indicates that these means are significantly different ($p=0.004$). Figure 33 shows that no Right Fork sample has scored in the excellent range since 1998.

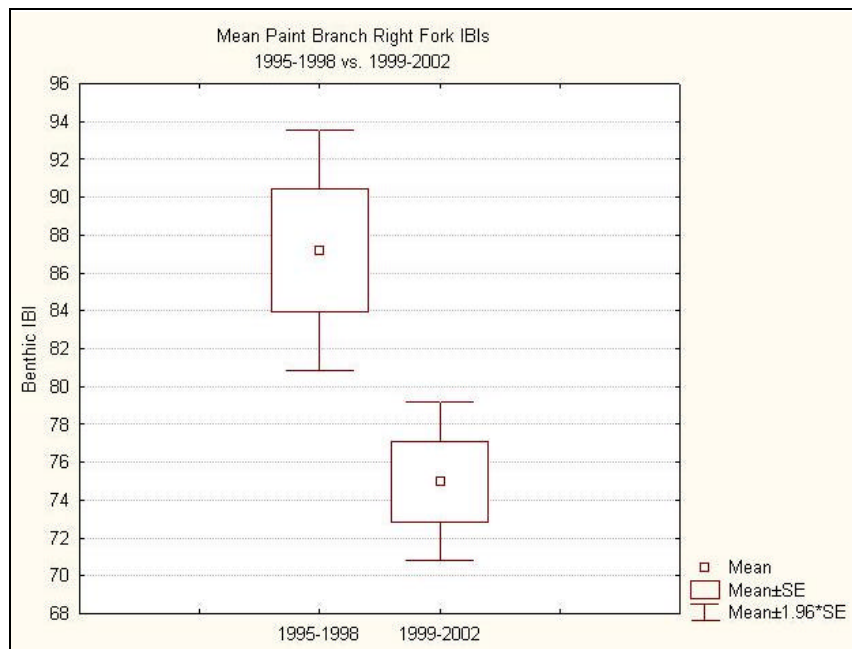
Figure 34 Mean Right Fork Benthic IBIs

DEP suspects that land disturbance on the Peach Orchard/Alnutt development, located in the headwater area of the Right Fork may be a factor in this decline. Development of the site began in May of 1997. Construction was stopped in 1998 because Maryland – DOT purchased the site to hold as an alternative ICC alignment. The sediment control ponds remain on the site and are inspected/maintained by Maryland Department of the Environment. While no sedimentation in the stream has been observed downstream of the MD-DOT property, we have observed turbid water leaving the site after larger storm events. There are extensive ATV trails on the site that are subject to erosion and some bank erosion has been observed where drainage from the site enters the right fork of Paint Branch. The sediment ponds on the site could also be a source of thermal impacts. In the winter of 2002-3 the site was used to store snow cleared from area roads.

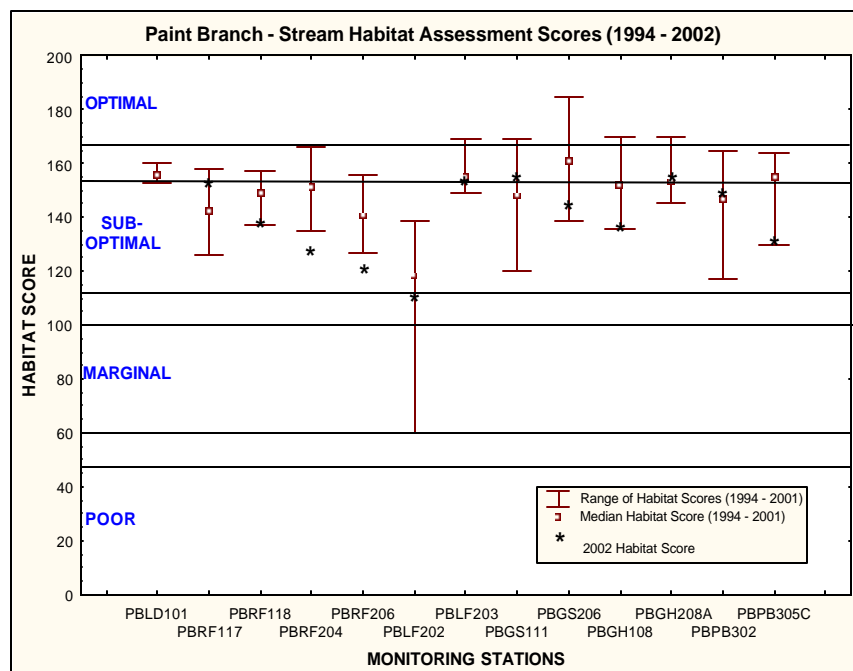
Figure 35 Results Of All Rapid Habitat Assessments Completed In Paint Br.

The range of all habitat assessment scores from Paint Branch are summarized in Figure 35. These assessments are done whenever a site is visited for monitoring in spring, summer or fall. Habitat scores have generally remained in the sub-optimal range at all stations. This means that overall habitat conditions of the Upper Paint Branch are adequate to support a diverse and healthy biological community. However, results obtained during 2002 from two Right Fork stations (PBRF204 and PBRF206) show some decline in stream habitat quality. Stream habitat parameters that account for the decline include: 1) channel flow status 2) epifaunal substrate and 3) embeddedness. These parameters could be showing impact from extreme drought in 2002. Channel flow status is a habitat parameter that rates the proportion of stream channel that is under water. A stream channel that contains water from bank to bank is scored high while a trickle of water through a wide stream channel is scored low. Many streams were rated low for channel flow status during 2002 because of drought conditions. The

epifaunal substrate habitat parameter rates the quantity and variety of natural structure in the stream, such as cobble, large rocks, fallen trees, logs and undercut banks available for refugia, feeding or spawning. A stream rated as optimal contains a variety of different sized stones and woody material. Lower scores for epifaunal substrate in the Right Fork could be related to the lower flows in 2002. Lower embeddedness scores mean a greater amount of sediment has been deposited on and around the

cobble and gravel in the stream. During drought, there may not be enough water to flush sediment out of the interstices of the stream bed. Alternatively, a greater amount of sediment could have entered the stream, presumably from active construction currently underway within the Right Fork drainage area. The Hunt Lions Den project is currently under construction there.

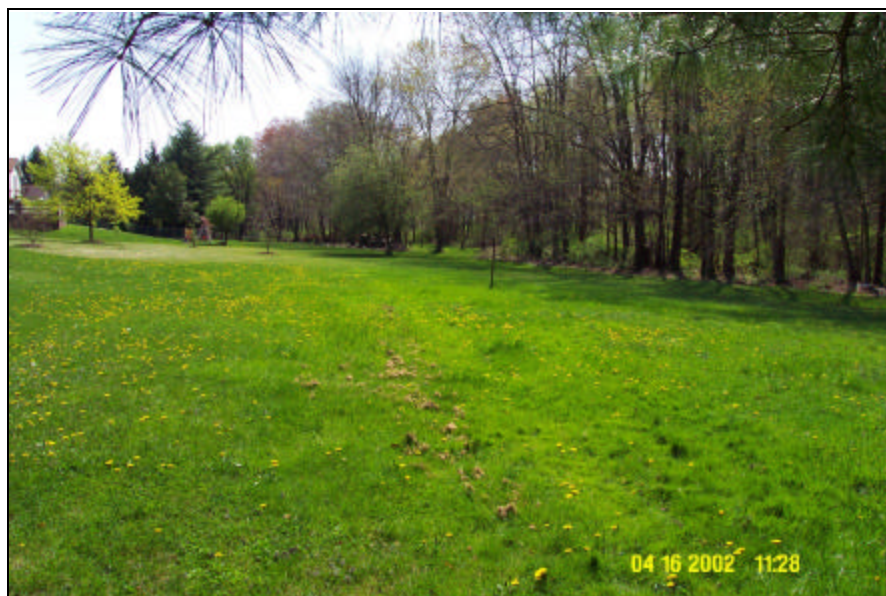
Encroachment onto public lands has been identified as a primary cause of poor riparian forest buffer along several Paint Branch tributaries. The Montgomery County Water Quality Advisory Group (WQAG) adopted a resolution (No. 04-2001) on September 10, 2001 proposing certain actions to address this matter (SPA Annual Report For 2001).

Figure 35 Before Property Markers Were Installed

During 2002 M-NCPPC notified land owners along portions of the Left Fork that they were illegally clearing and mowing public property. Additionally, new park boundary markers were installed clearly delineating property lines. Since M-NCPPC has taken these actions, adjacent property owners have ceased to clear park land (see before and after comparisons of stream buffer vegetation since parkland boundaries were delineated –Figures 36, 37 and 38). This will significantly widen the stream buffer which can only help to improve overall stream quality by providing additional shading and food to the stream ecosystem.

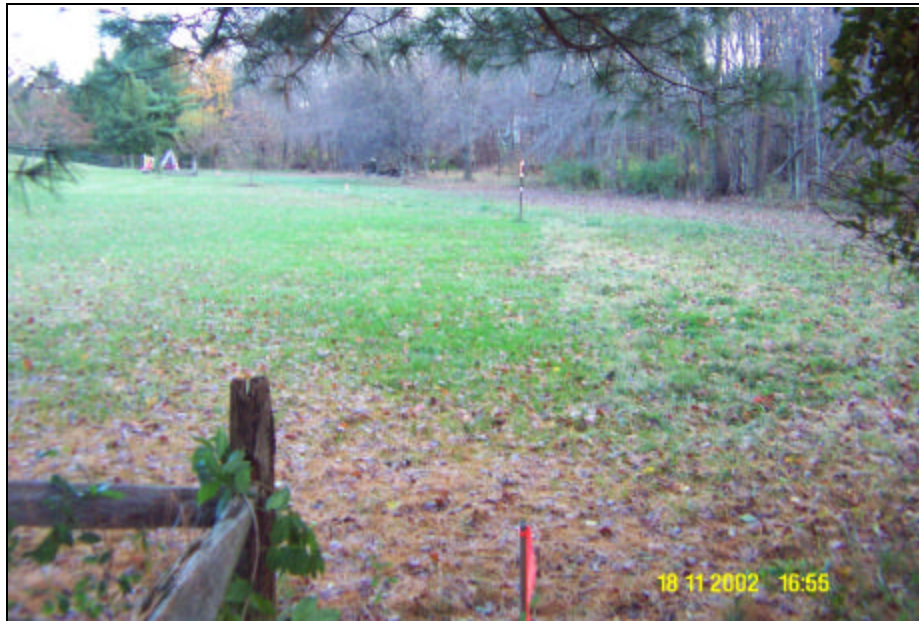
Figure 36 After Property Markers Were Installed

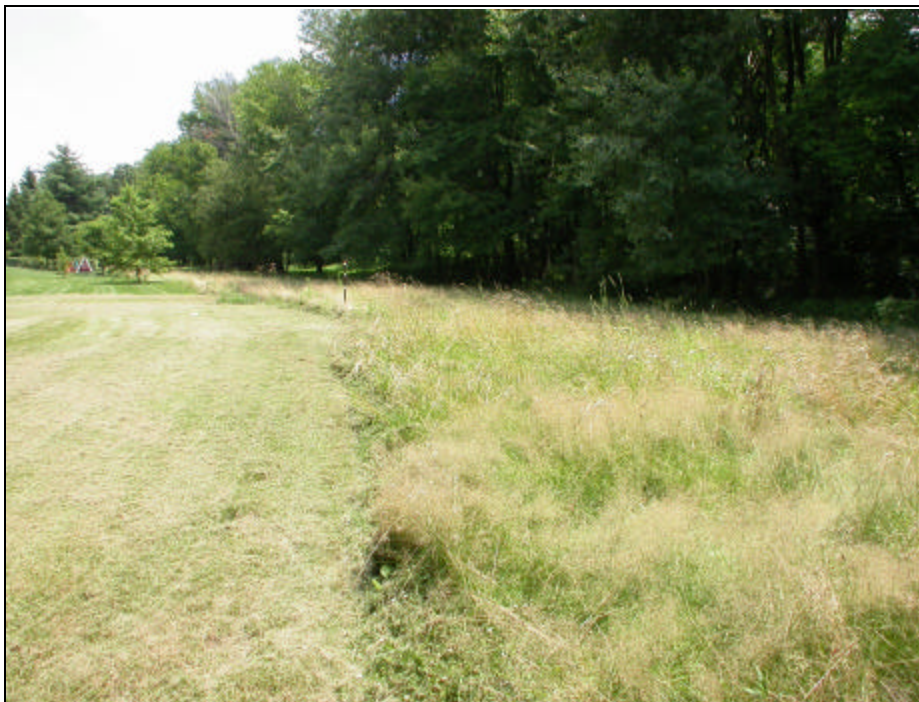
Figure 37 July 2003 Park Property No Longer Being Mowed

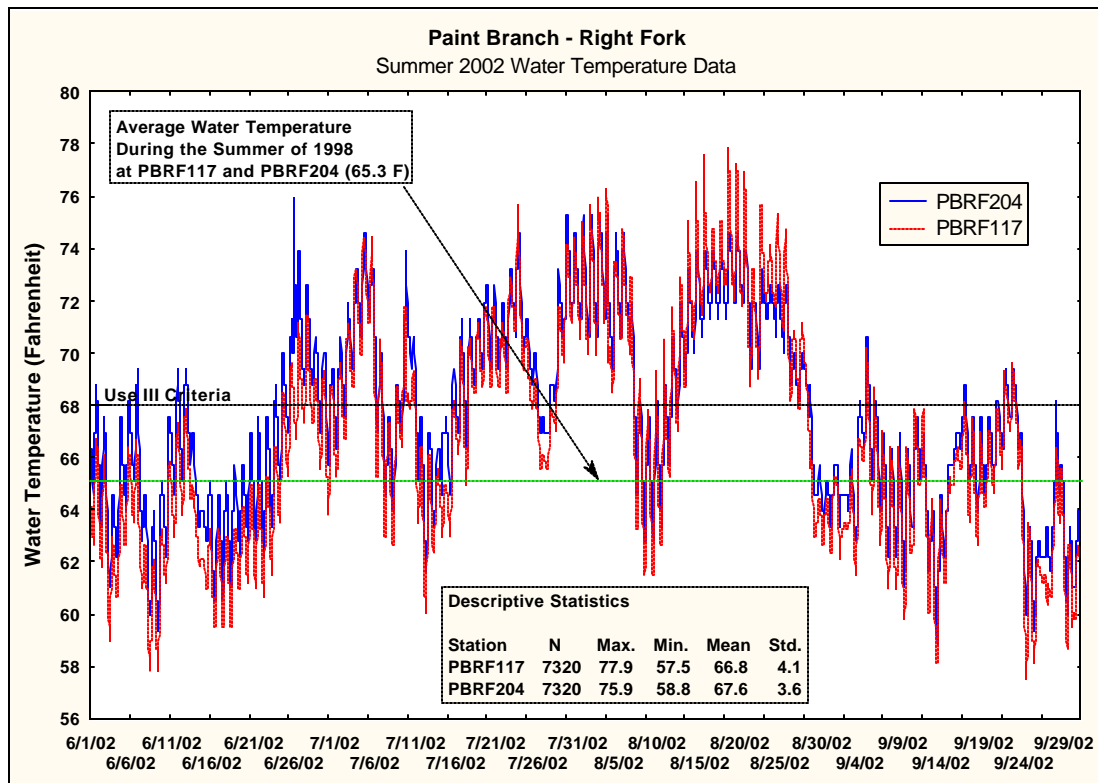
Figure 38 Stream Water Temperature Data From the Right Fork

Temperature loggers were deployed in the Right Fork at two locations, PBRF117 and PBRF204. Results presented in Figure 38 show water temperatures exceeding the Maryland Use III criteria of 68⁰ F throughout much of the summer. Average water temperature for the period of 6/1–9/30 was 2⁰ F warmer than 1998 when summer air temperatures were near normal. Results of fish sampling, completed in late September at two Right Fork stations (PBRF117 and PBRF204) indicate that the warm water temperature had no impact on overall community health. These sites had very high fish IBI scores in 2002. High temperatures may have had an impact on trout here though, as only two adults were collected at PBRF204 and no trout were collected at PBRF117 (Table 17). This could also be a residual impact of the 1999 drought. Since the drought of 1999 all seven samples collected at these two sites had three or fewer trout. Prior to 1999, six samples out of eight collected here had 4 or more trout and the average sample had 7.75 trout. It is possible that overall trout populations are down since

1999 and fewer were found here in 2002 because the remaining fish are exhibiting a preference for other portions of the Paint Branch watershed where more stream flow was available.

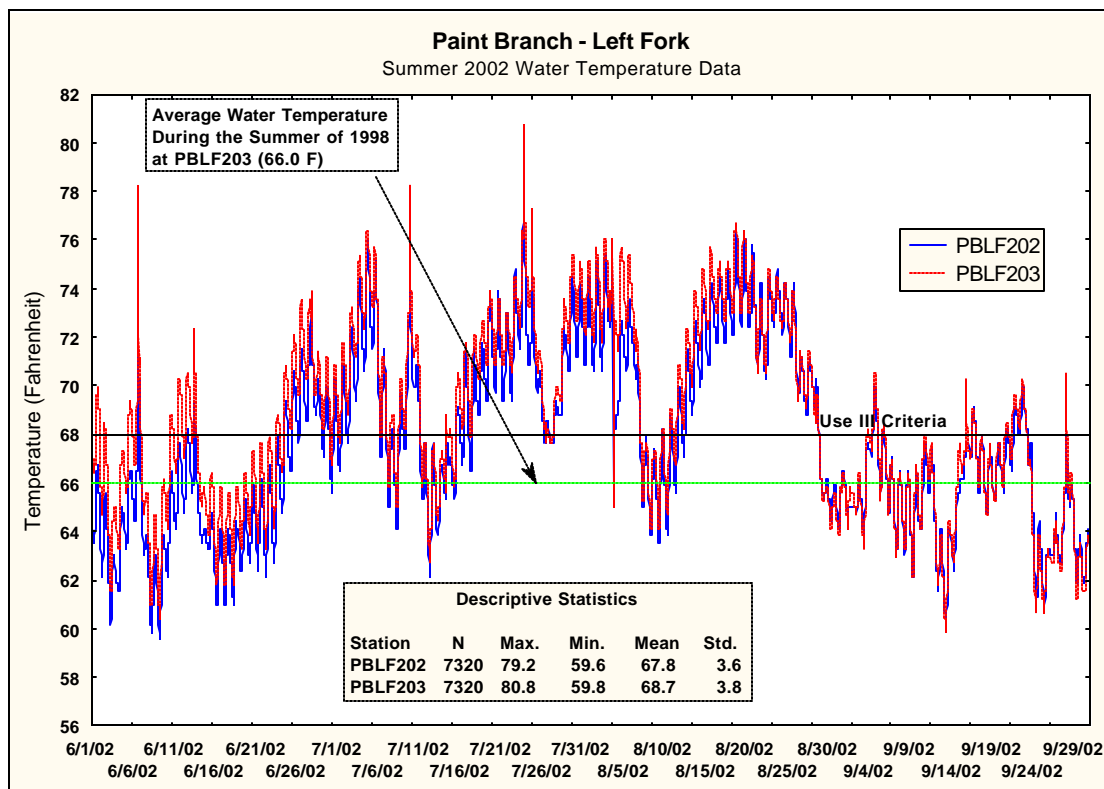
Figure 39 Stream Water Temperature Data From The Left Fork

During summer of 2002 temperature loggers were deployed at two locations within the Left Fork, PBLF202 and PBLF203. Results are presented in Figure 39. Water temperature remained above the 68° F Use III criteria for most of the summer. Several brief temperature spikes occurred during the summer of 2002 on 6/6, 7/9 and 7/23 all of which correlated with brief (15 to 45 minute) storm events.

A temperature study of the Left Fork conducted by DEP during the summer of 1998 found that the Rainbow Drive tributary was the source of elevated temperatures and temperature spikes during storms (SPA Annual Report, June 2000).

Short, intense summer thunderstorms often cause a pulse of warm water runoff from heated street, parking lot and rooftop surfaces in streams. Interestingly, temperature spikes were greater in the lower Left Fork (PBLF202) than any other area of Paint Branch monitored during 2002. Two possible explanations for this include: 1) The in-line stormwater management pond on a tributary to the Left Fork at Rainbow Drive discharging pulses of warm pond water during storm events and 2) curb and gutter being the primary means of stormwater conveyance in residential neighborhoods along the Left Fork between PBLF202 and PBLF203 quickly conveys stormwater from heated road surfaces to streams.

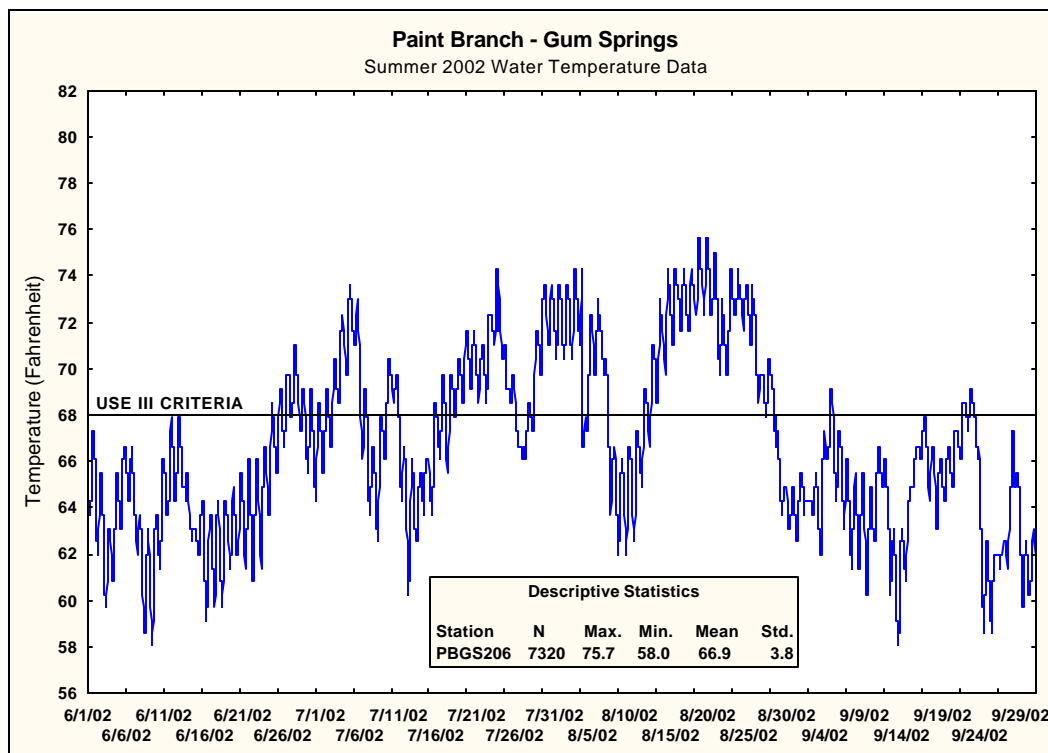
Figure 40 Stream Water Temperature Data From Lower Gum Springs

One temperature logger was placed in lower Gum Springs tributary at PBGS206. Results show little or no temperature spikes during storm events (Figure 40). It should be noted that much of the development on the east side of Gum Springs tributary uses open section road for stormwater conveyance. Newer development on the west side uses curb and gutter. However, most of the west side development drains to the Oak Springs pond which has recently been retrofitted with a by-pass pipe to convey pond outfall 1,900 feet to the Paint Branch mainstem thus by-passing Gum Springs tributary.

Although water temperatures remained above the Maryland Use III criteria for extended periods during the summer of 2002, average temperature in lower Gum Springs was among the lowest of all areas monitored in Paint Branch. This is further evidence of how the Gum Springs by-pass pipe has lowered stream water temperature creating more favorable conditions for the naturally reproducing Brown trout.

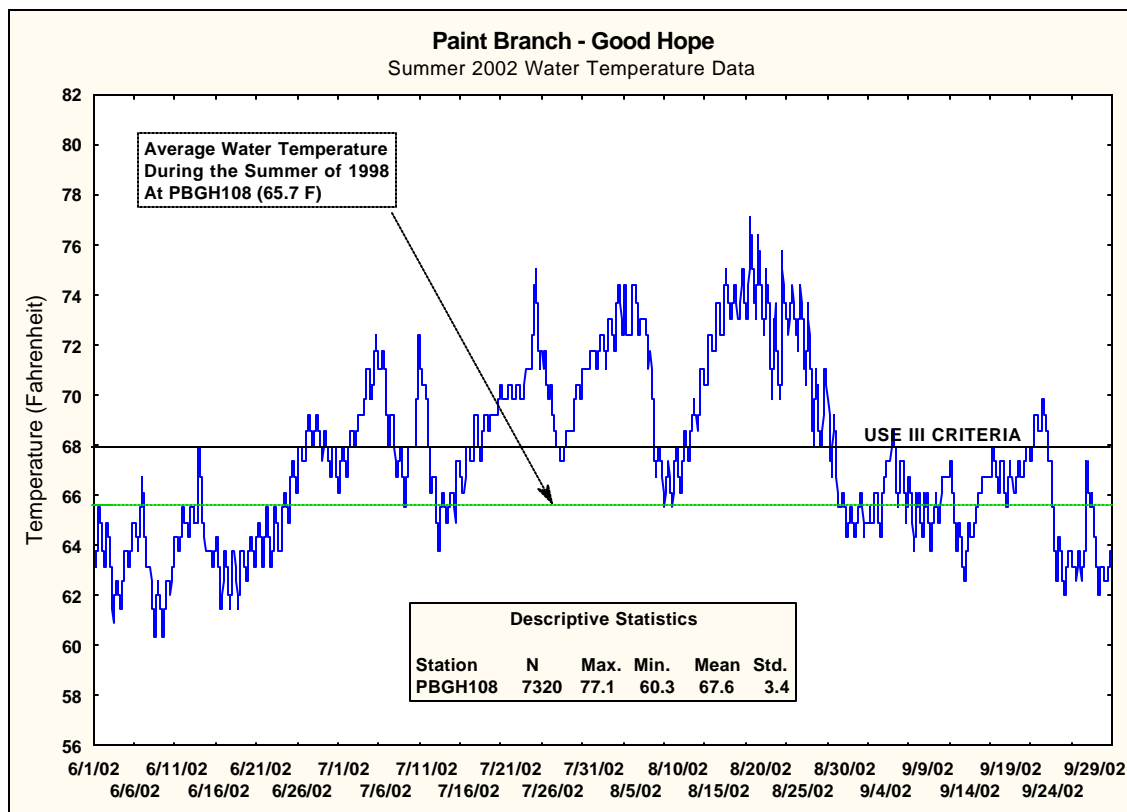
Figure 41 Stream Water Temperature Data From Upper Good Hope

One temperature logger was deployed in the upper portion of Good Hope tributary at PBGH108. Results show water temperatures remained above the Maryland Use III criteria for extended periods (Figure 41). Average water temperature was 1.9⁰ F higher during the summer of 2002 then the more normal year of 1998. Temperature spikes during summer storms did occur in 2002 but were not as high as in the Left Fork.

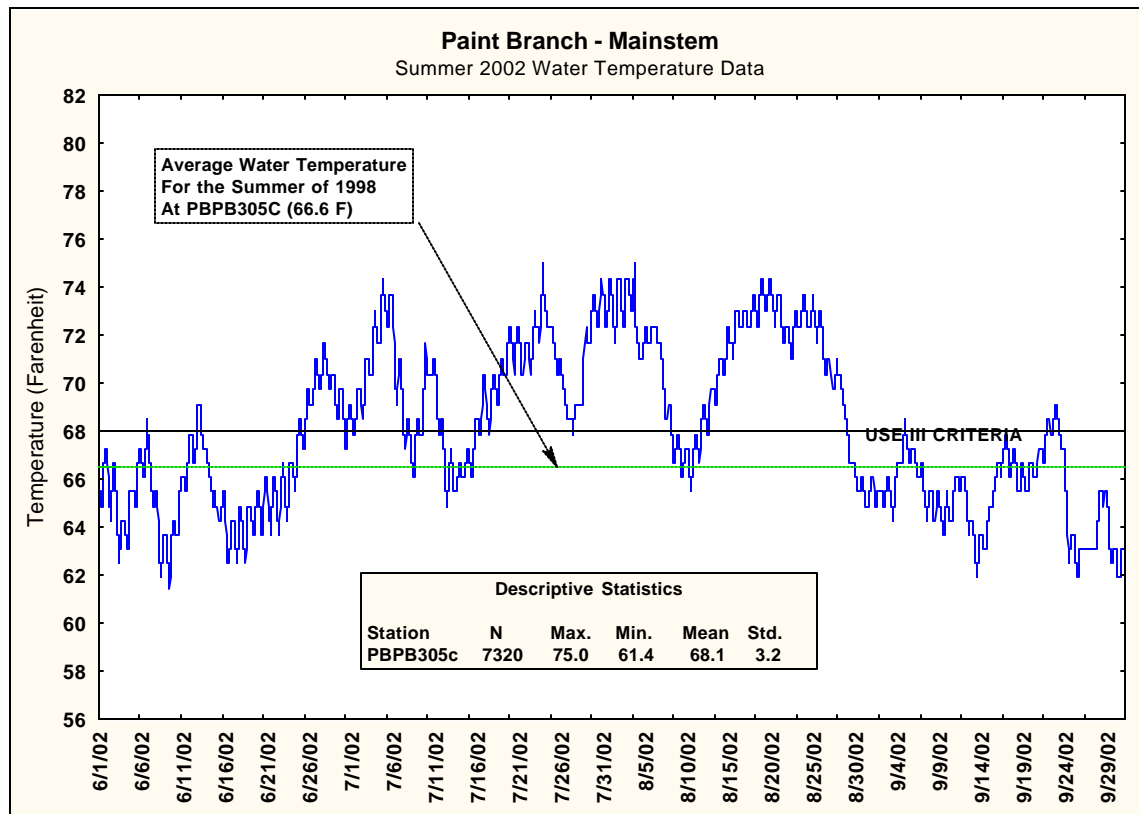
Figure 42 Water Temperature Data From Paint Branch Mainstem

One temperature logger was deployed in the Paint Branch mainstem during the summer of 2002 just upstream of Fairland Road at PBPB305C. Results show water temperatures remained above the Maryland Use III criteria for extended periods just as at all other locations monitored in the Paint Branch SPA (Figure 42). Temperature spikes are not apparent in the data due to the mixing effect in the higher flowing mainstem.
