# Montgomery County Special Protection Area Program Annual Report - May 2001

Department of Environmental Protection

# **SPECIAL PROTECTION AREA PROGRAM 2000 ANNUAL REPORT**

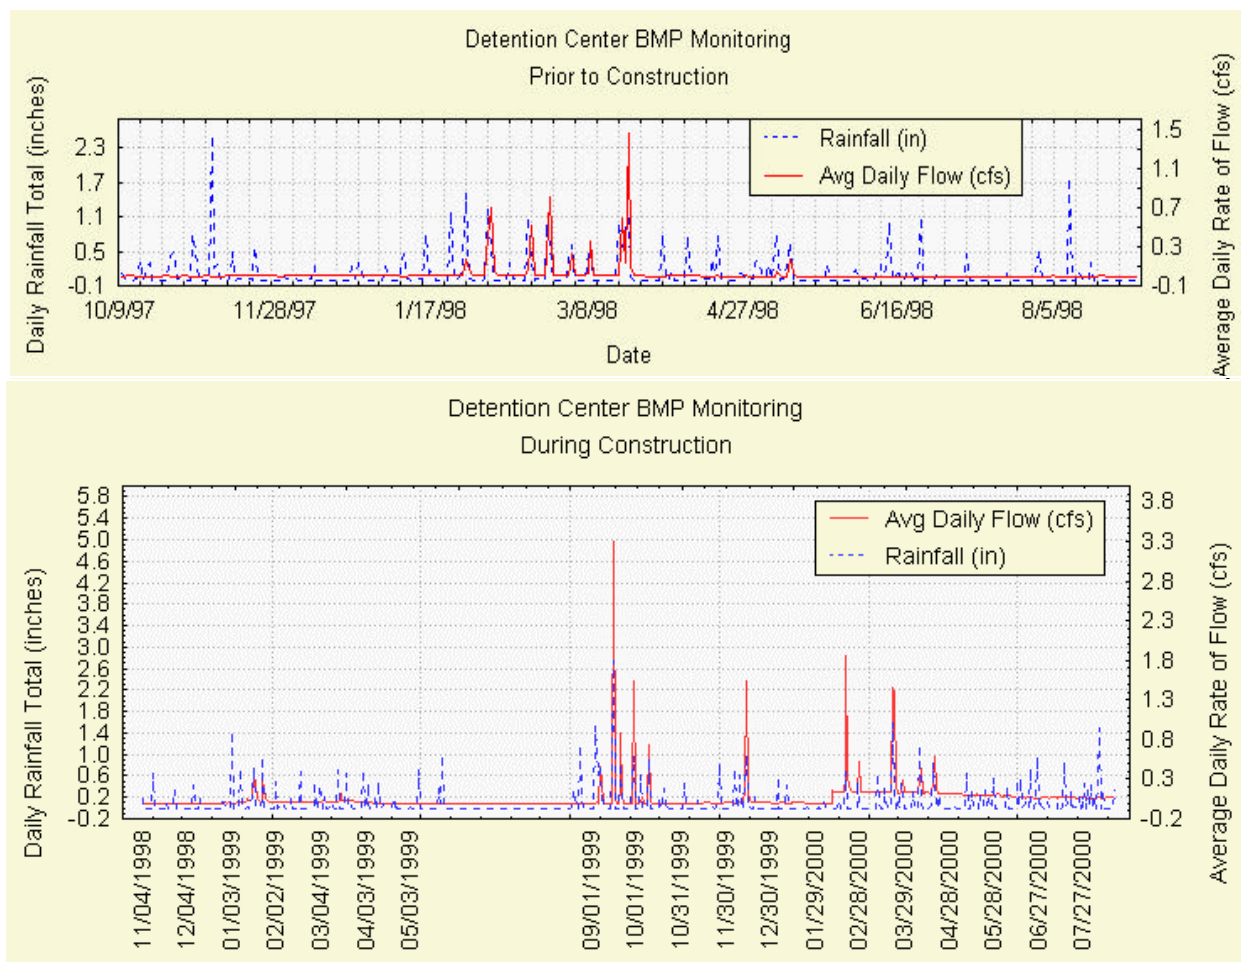
Figure 4 shows the rainfall and flow from the pond prior to and during construction. The plot of flow appears different from the plot included in last year's report. This is because we have determined that several data points on last year's graph resulted from false readings. This conclusion was reached following discussions with the consultant responsible for the BMP monitoring and close examination of the data and weather records. These readings were produced when the monitoring equipment froze during extremely cold weather. The erroneous data points have since been deleted. The data also indicates that there was an abrupt increase in baseflow in January of 2000 immediately after the equipment is suspected to have frozen. This apparent increase in baseflow is not considered to be an actual occurrence. The freezing of the equipment may have affected its calibration. Plotted storm data is only slightly affected by this situation. Additionally, the plot does not show rainfall or flow from May 26 1999 through August 17, 1999. This is not a problem as that was a drought period and there was little rainfall in the area during that time span.

The data shows that the sediment pond is performing as expected with respect to controlling peak runoff flows. In its construction phase, the site is not generating frequent large flows that would lead to drastic changes in the flow regime of the local streams. Increased storm flows can cause erosion and be very harmful to the biology of a stream. A storm that delivered 3.03 inches of rain in a 24 hour period produced an outfall flow rate from the pond of 15.79 cfs on 9/16/99. Observed storm runoff rates are not inconsistent with the final design parameters of the pond. When converted to its final configuration, the pond is designed to receive 28 cfs during a two year storm and release water at a rate of 9.9 cfs. A two year storm in Montgomery County is a rain event that brings 3.2 inches of rain within a 24 hour period. Peak flow rates for several storms prior to and during construction are given in Table 5.

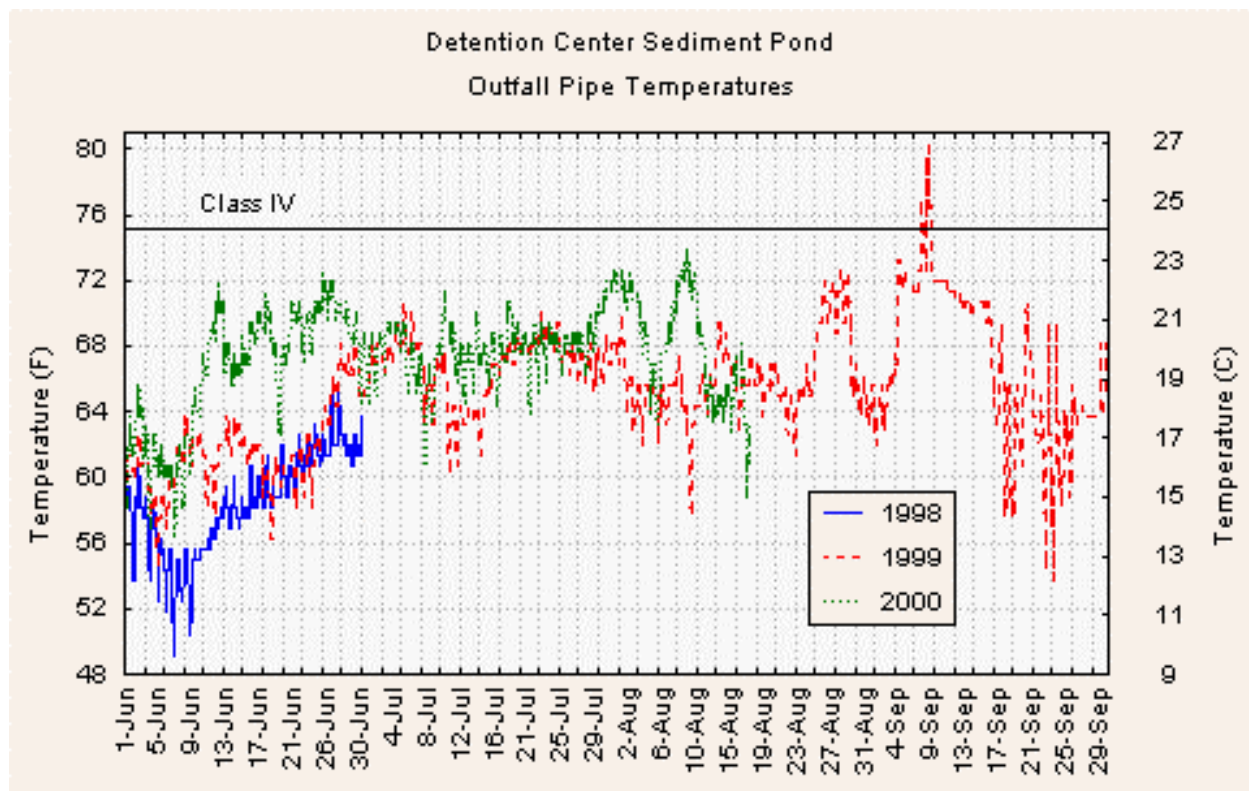
The temperature of the water leaving the pond continues to be well moderated. Temperatures in the outfall pipe are graphed in Figure 5. The graph indicates that the pond released water warm enough to stress stream organisms on only two occasions. On September 7 and September 8, 1999 temperatures exceeded 75 degrees for a total of 15 hours and 15 minutes. The maximum recorded temperature was 80.3 degrees. Examination of the graph of flow from the pond (Figure 4) indicates a rainfall and flow event on that date following a prolonged dry period.

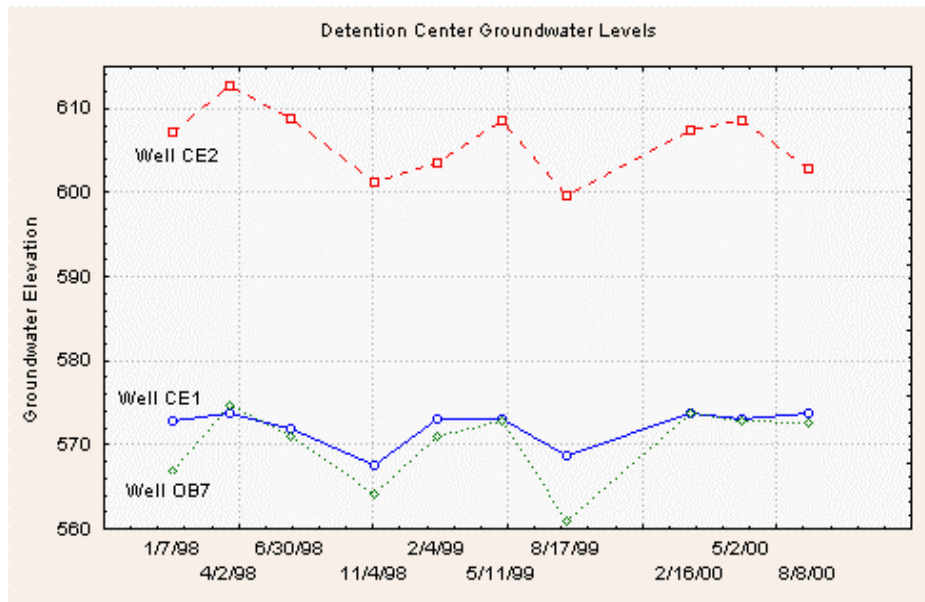
Groundwater levels at the jail site seem to maintaining consistent levels. Figure 6 shows groundwater levels in three observation wells on the site. All three wells show a slight lowering of the water table during a drought period in late summer 1999. The groundwater readings returned to normal levels in winter 2000. Future monitoring will indicate whether

development of the site results in a lowering of the water table. Increased imperviousness associated with development can cause rainwater to runoff that otherwise would infiltrate into the soils and maintain groundwater levels.

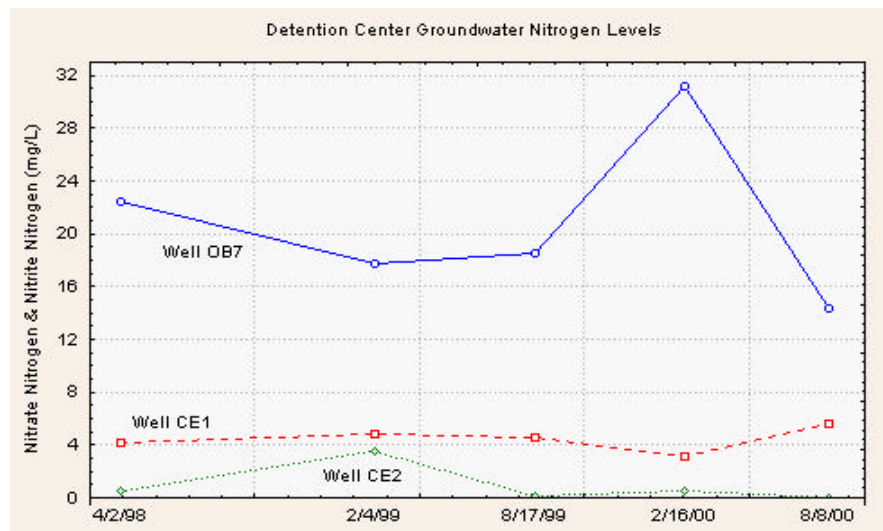
Nutrient monitoring of the groundwater at the site indicates elevated levels of nitrogen in well OB7 (Figure 7). The EPA drinking water standards for nitrate in well water call for a maximum concentration of 10 mg/L. Water in well OB7 has been as much as three times that standard. While this well is not being used for drinking water, these nitrogen levels indicate that local streams could potentially be receiving groundwater inputs with comparable levels of nitrogen. If levels of nitrogen in the streams reached these levels it could disrupt the ecology of the streams. Monitoring of the streams draining the site has not identified problems with biological communities. These elevated nitrogen readings are probably related to the former use of the site as a WSSC sludge entrenchment facility. Sludge contains high concentrations of nutrients.

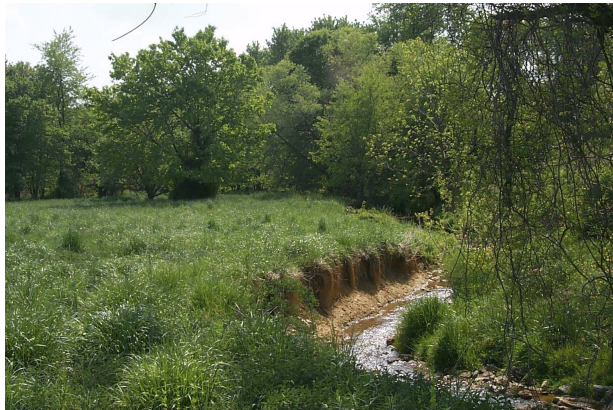
**Photo 1. Lack of forested riparian buffer at LSLS203, Photo 2. Sparse forest cover in riparian buffer at**

Results of rapid habitat assessments presented in last years SPA annual report revealed a problem with sediment deposition at station LSLS203. Monitoring results from 2000 indicate sediment deposition is no longer a problem at this station. It is possible that a pulse of sediment moved through the stream channel which was observed at this station during the spring of 1999. Pulses of sediment conveyed through a stream channel can come from a variety of sources such as: stored sediment behind a dam or road crossing suddenly released, bank failure, or land disturbance to name a few. The source of sediment observed at LSLS203 during 1999 was not determined and appears to have been a short term problem.

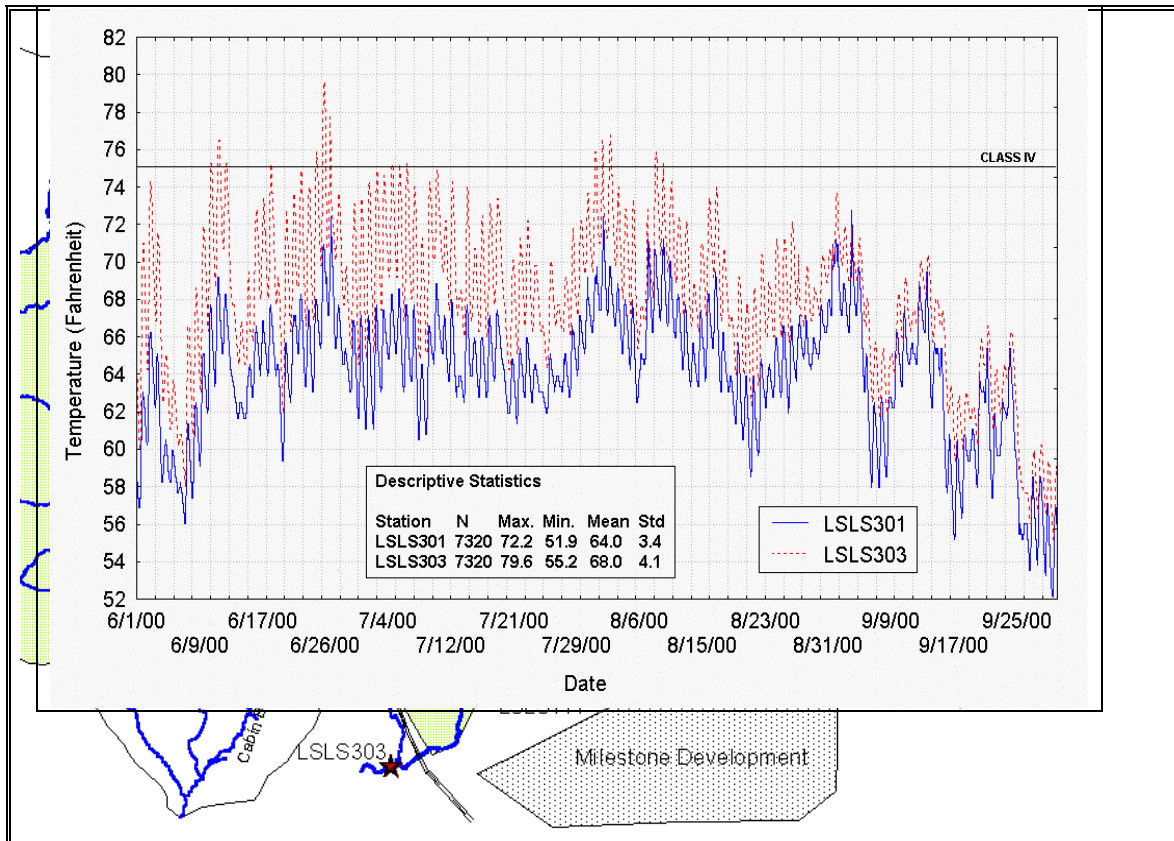
**Figure 17. Locations of continuous water temperature loggers during the summer of 2000 are shown with red stars.**

All tributaries of Little Seneca Creek, upstream of Little Seneca Lake are designated as Use IV-P (Recreational Trout Waters and Public Water Supply) by the State of Maryland. All tributaries of Ten Mile Creek are designated as Use I-P (Water Contact Recreation & Protection of Aquatic Life). Water temperature criteria for Use IV-P and I-P is 75° F and 90° F., respectively, which means that discharges to the creek can not result in ambient water temperature that exceeds these criteria. At station LSLS301 the 75 degree criteria was exceeded on fifteen days during 1999 and 0 days during 2000. The 1999 condition seemed to primarily reflect the hot, extremely dry drought period which impacted all County streams.

Summer of 2000 is the third year that water temperature loggers have been deployed at station LSLS103C along the Town Center Tributary (figure 17). The purpose of placing a logger here for a third summer was to provide additional data for the establishment of baseline water temperature conditions before construction of the new Clarksburg Town Center. During the three summers of monitoring, stream water temperature never rose above the 75 F. degree Use IV-P criteria. The fact that this small tributary maintains cool water flow during the stressful

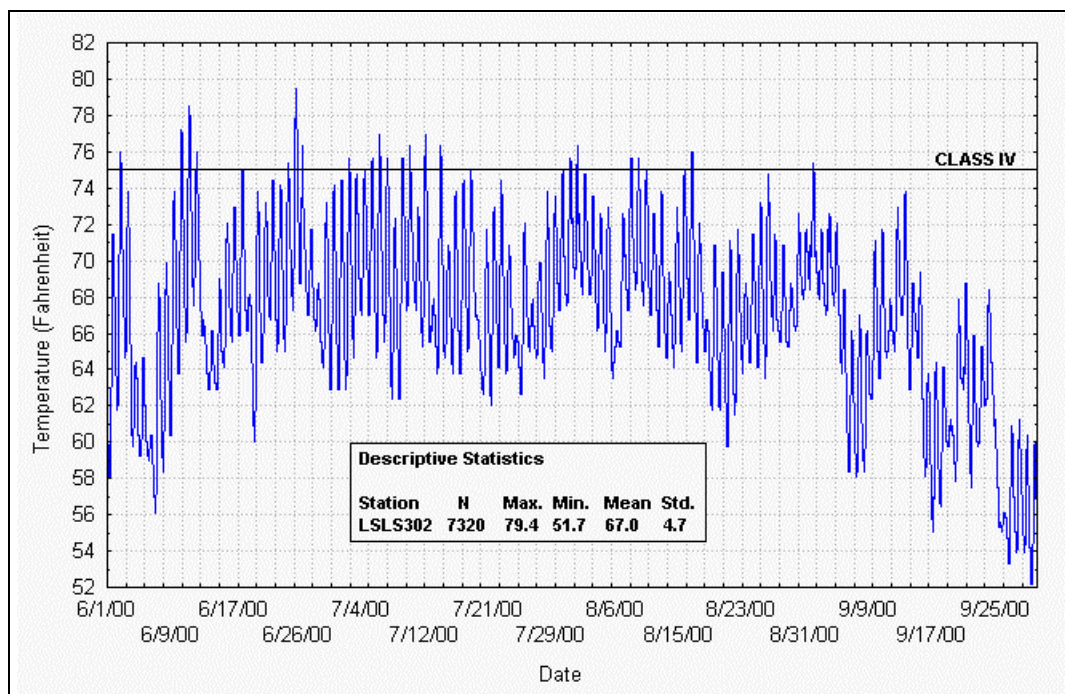
**Figure 18. Water Temperatures from Stations LSL301 and LSL303**

Much of the Little Seneca Creek mainstem, between stations LSL301 and LSL303 has little or no wooded riparian area and consequently no shading to keep water temperatures low during the summer months (see photos 3 and 4). We have documented a decline in biological condition (excellent to fair for benthic macroinvertebrates) between these stations and have theorized that one of the causes is increased water temperatures. Temperature monitoring during the summer of 2000 was set up to address the question.

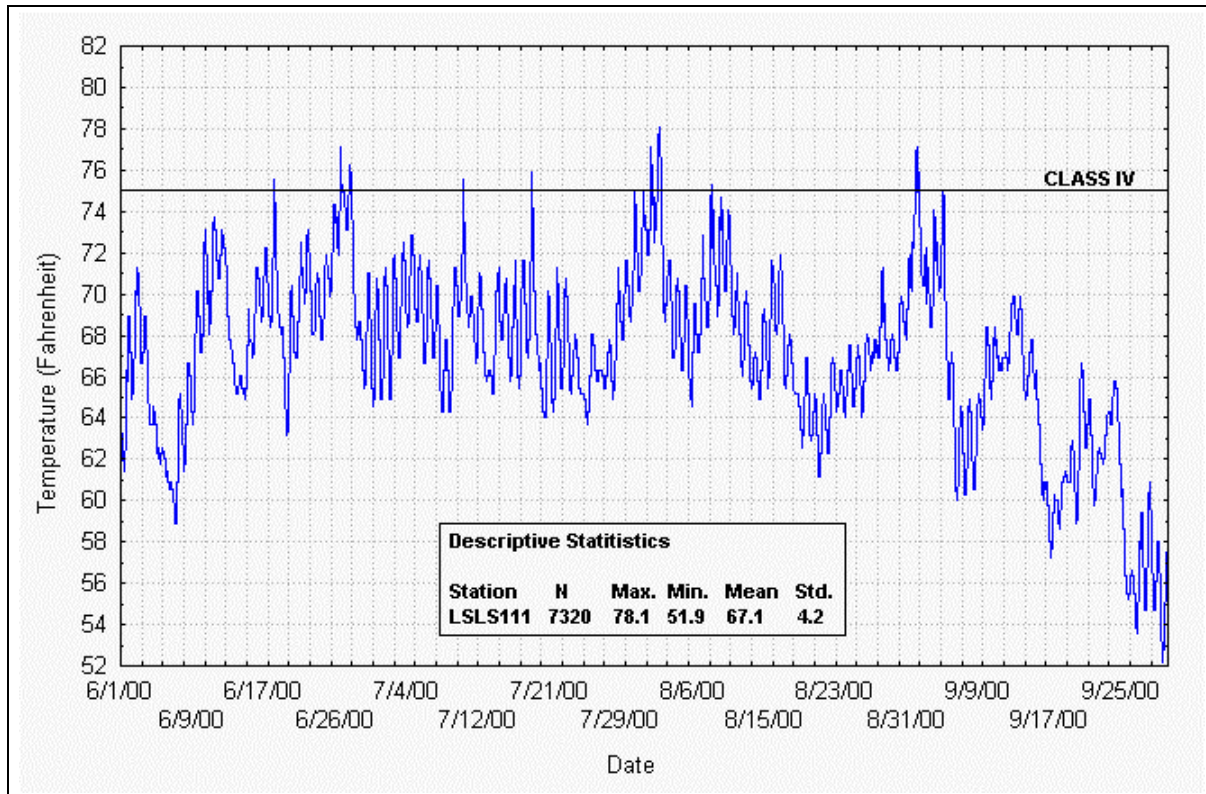
summer months is the primary reason for a stable biological community which we have documented over the past five years. A summary of results from three years of continuous water temperature monitoring at station LSLS103C is presented in Table 7.

We have shown that stream water temperatures in the Town Center tributary remain cool during summer months which is the primary reason for a stable biological community in this tributary. It is hoped that this condition will remain after construction of the new Clarksburg Town Center. Stormwater management accompanying planned development have incorporated various methods (ie. infiltration, coolwater recharge) into the site design to mitigate impacts of anticipated increased runoff temperatures.

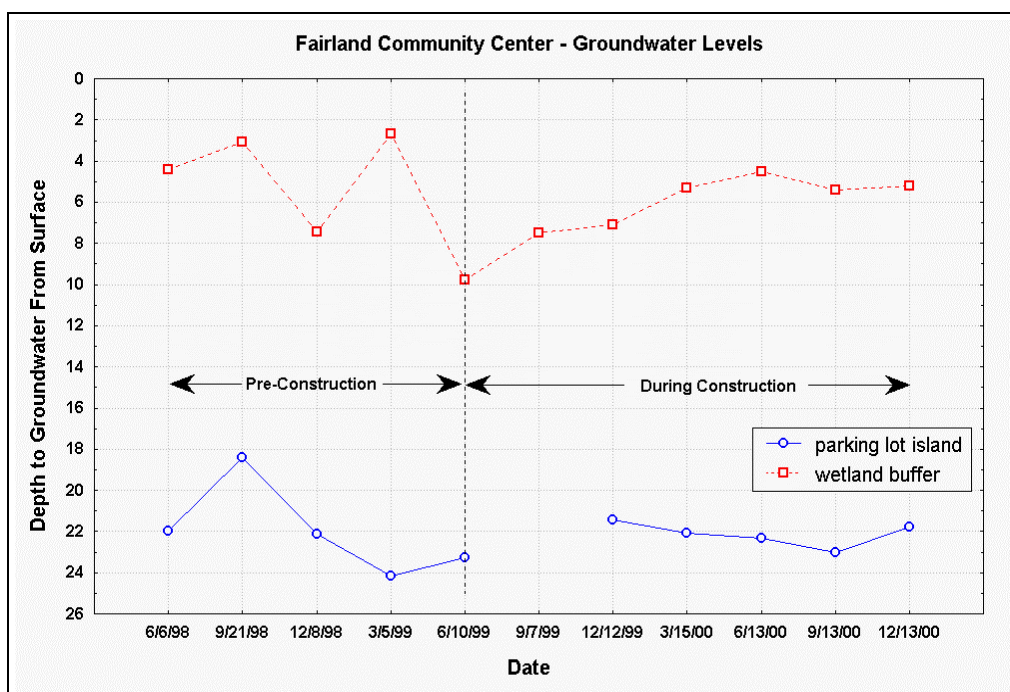
The wetland well indicates low groundwater levels during the drought of 1999 (6/99) followed by a steady recovery. Water levels in the parking lot well reached a low in 3/99 which is odd considering this is typically the wettest time of the year. Also, there is very little recovery from low levels reached during 1999 in comparison to both the wetland well and the USGS control well. This suggests that construction activities in the parking lot area may already be hampering groundwater recharge there. As part of the site design for this project, "clean" rooftop runoff is to be infiltrated into the ground along the back side of the building to compensate for the lost ability to recharge groundwater.

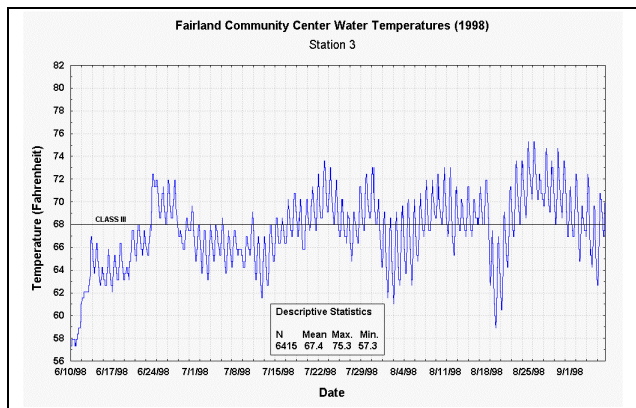
**Figure 24. Water Temperatures from Fairland Community Center During 1998**

Continuously recording water temperature loggers are deployed in the stream receiving runoff from the Fairland Community Center. Findings from this monitoring indicate that water temperatures, during summer months, are frequently above the sixty-eight degree standard for Use III streams (Figures 24, 25 and 26). Water temperatures were over the 68 degree standard 63% of the time they were monitored during the last three summers. Temperatures frequently exceeded the standard for long continuous periods of time also. In 1999 temperatures were over the standard for a continuous period that exceeded 19 days. This was a drought year however. The longest continuous period over the standard exceeded eight days in 1998. Temperatures were above the standard for a continuous period of over eight days in 2000 also. Maximum temperatures were 75.3 degrees in 1998, 81.7 degrees in 1999 and 80.6 degrees in 2000. Average water temperatures during 1998, 1999 and 2000 were 67.4 °F, 71.9 °F and 70.1 °F respectively. Water temperatures have been higher for two years following the pre-development monitoring of 1998. Summer of 1999 was very hot and dry which would explain the warmer temperatures. However, summer of 2000 was relatively cool and wet but average temperature was still three degrees warmer than 1998.

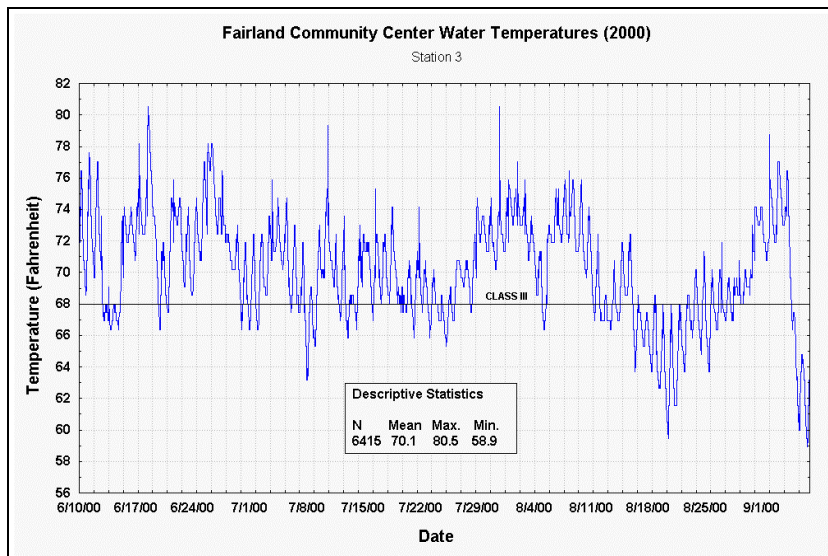
**Figure 26. Water Temperatures from Fairland Community Center During 2000**

Trout are found in the right fork of Paint Branch above and below where this tributary enters the stream. If the water in this tributary does not cool off before it enters the right fork of Paint Branch, it could potentially have negative effects on trout. Warmer water temperatures during construction may be from the sediment pond which holds water for extended periods of time. It will not be until after the sediment pond is converted to a water quality pond that an assessment of BMP performance can be made regarding temperature impacts.

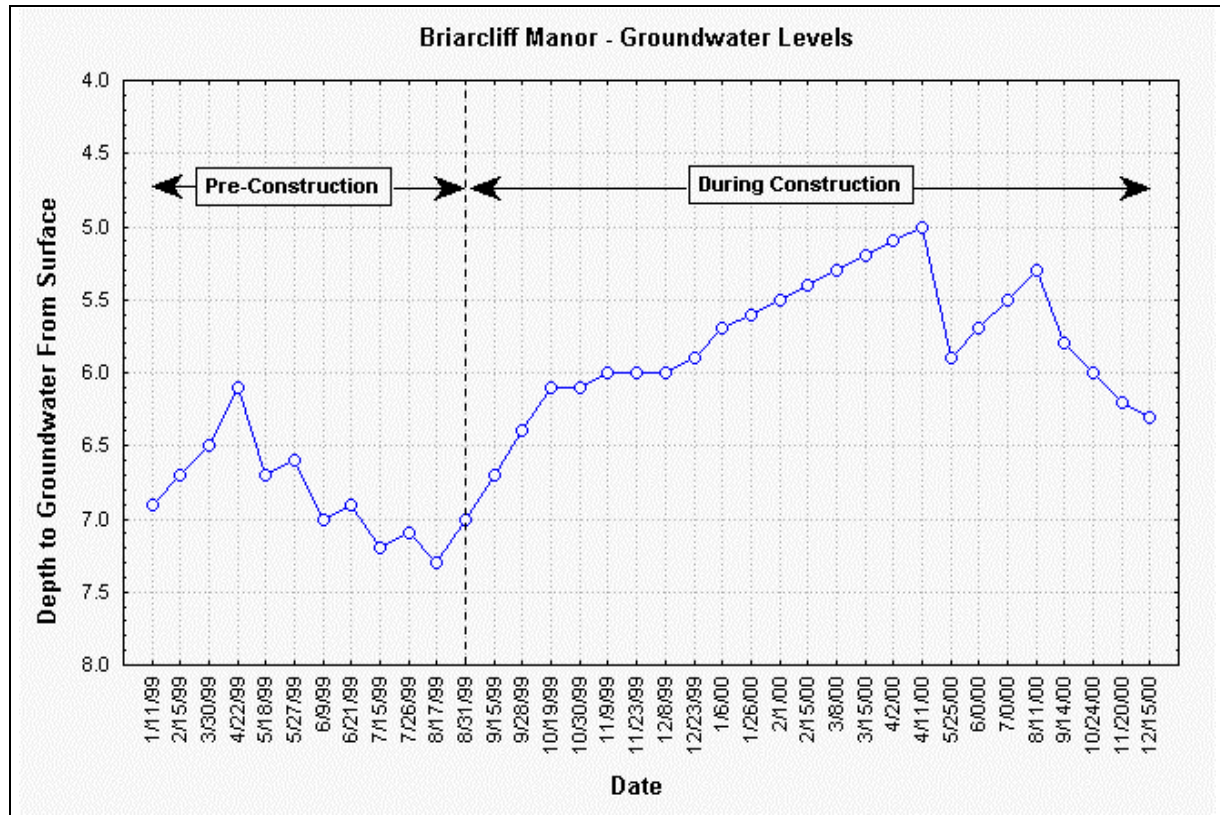
Figure 27. Groundwater Readings from Briarcliff Manor

All groundwater readings taken from the observation well thus far are plotted in Figure 27. As can be seen in the graph groundwater levels reached a low point during the period of June - August, 1999. This is related to drought conditions experienced throughout the region during this period. For the pre-construction period (1/99 - 8/99), average groundwater level was 6.8 feet, while the during construction period (1/2000 - 8/2000), averaged 5.4 feet. Again, lower groundwater readings during the pre-construction period are due to drought conditions.

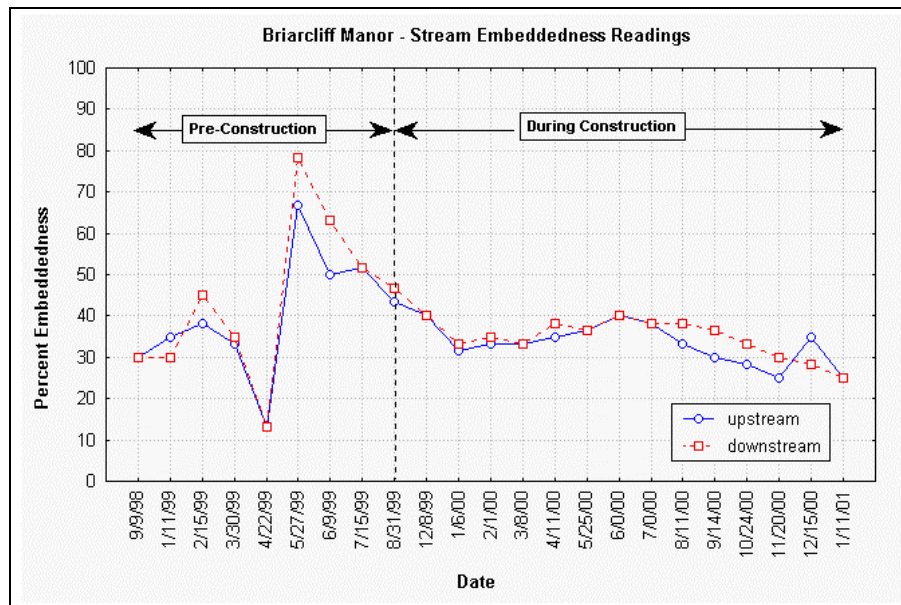
### **Figure 28. Embeddedness Readings from Briarcliff Manor**

Embeddedness readings are taken in the receiving stream, above and below the main sediment pond outfall. The purpose of this monitoring is to evaluate the effectiveness of sediment control during construction. Embeddedness readings taken thus far are presented in Figure 28. The figure indicates that observations were similar at both stations. There are however, periods when readings from the downstream station are slightly higher. However, the small difference in percent embeddedness is considered minor given the relatively subjective nature of the visual observation technique of the embeddedness test. The figure reveals that embeddedness did not greatly increase below the site during construction, suggesting that sediment controls on the site are keeping most of the sediment out of the stream.

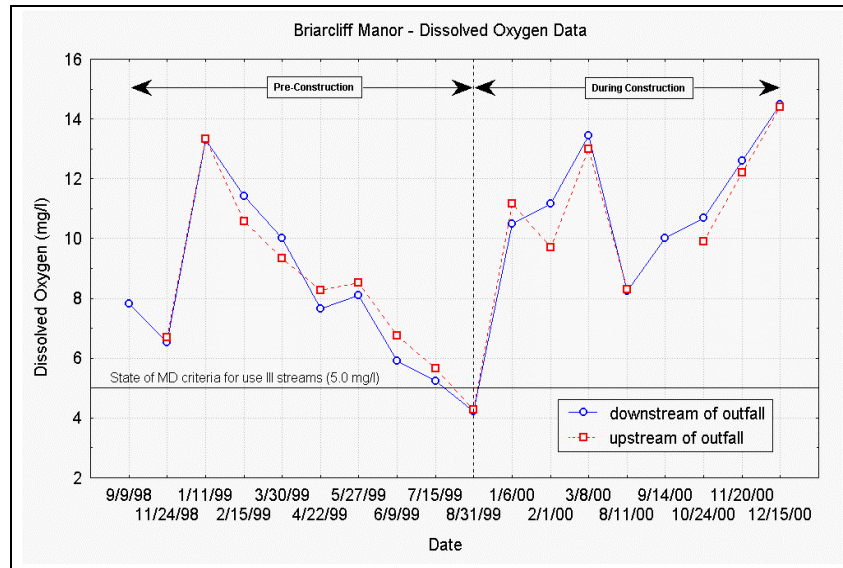
**Figure 29. Dissolved Oxygen Readings from Briarcliff Manor**

Water quality readings (dissolved oxygen, pH, conductivity, temperature) are taken at the same two locations as embeddedness. The purpose of this monitoring is to determine if water quality is impacted by outfall from the stormwater management pond. Dissolved oxygen data obtained thus far are presented in Figure 29. Dissolved oxygen levels dropped below the State of MD criteria of 5.0 mg/L during August of 1999. Low dissolved oxygen readings taken here and at other locations in the Paint Branch watershed during this period are considered drought related. Other water quality parameters (pH, conductivity) have shown no difference, either between stations or before and during construction.

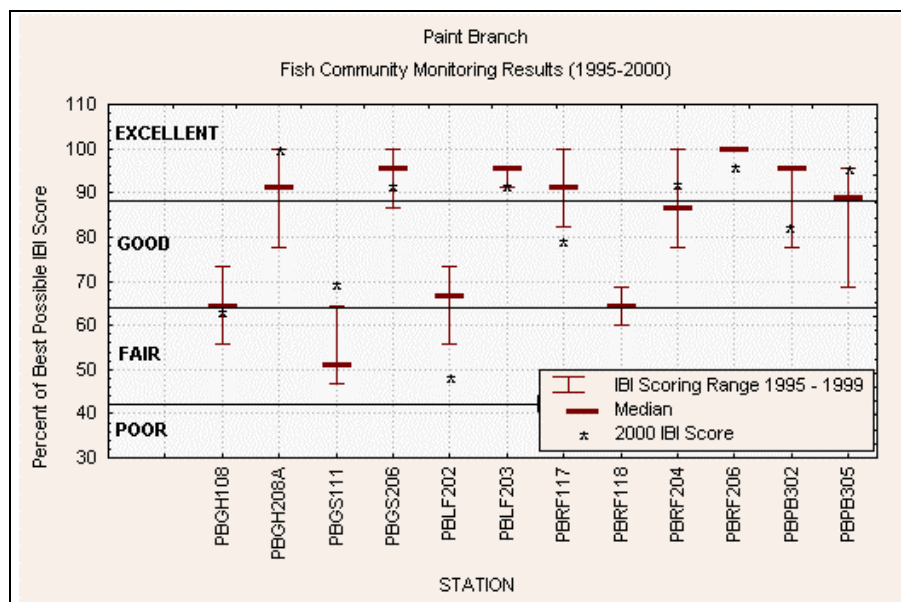
Fish sampling was completed at eleven stations during 2000. Results (Figure 31) suggest that the drought of 1999 had little impact on the fish community as a whole. However, numbers of Brown Trout adults and young-of-year were lower throughout the watershed. The Right Fork was particularly hard hit as Brown Trout were absent from all stations sampled (PBRF117, PBRF204 and PBRF206) for the first time since monitoring began in 1994. The rest of the fish community has remained intact. Because the IBI is meant to indicate the status of the fish community as a whole, the lack of Trout alone does not affect IBI scores greatly. IBI values at these three Right Fork stations remain comparable with previous years (Figure 31). Two stations (PBRF117 and PBLF202) experienced declines in IBI scores due to lower numbers of fish species that occupy the riffle habitat. These two stations are located in the upper portions of the Right Fork and Left Fork where stream flows were down to a trickle during the summer of 1999.

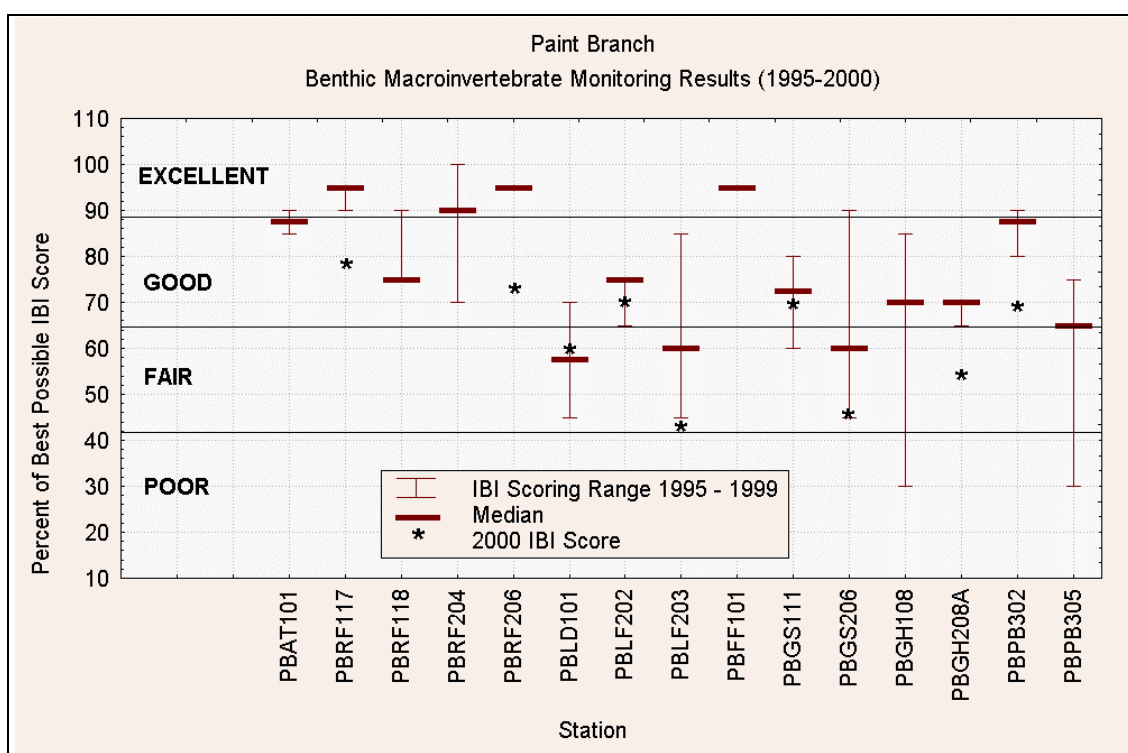
Sampling for benthic macroinvertebrates was completed at thirteen stations along the Paint Branch during spring of 2000. Benthic macroinvertebrates have been identified and results from nine stations are available for inclusion in this report. Six of these nine stations had IBI scores which were lower than all five previous years of monitoring (Figure 32). Low IBI scores from throughout the watershed are likely the result of drought impacts from the previous summer of

1999. Low water levels can expose shallow areas thus reducing the amount of habitat for benthic organisms. At low flows temperatures can also increase which results in lower concentrations of dissolved oxygen in the water. Both high temperatures and low dissolved oxygen concentrations can negatively impact benthic macroinvertebrates. Three stations (PBLD101, PBGS111 and PBLF202) were within the range of IBI scores from previous years. The benthic macroinvertebrate community in these three areas (upper right fork, upper Gum Springs and upper Left Fork) were apparently not impacted by the drought.

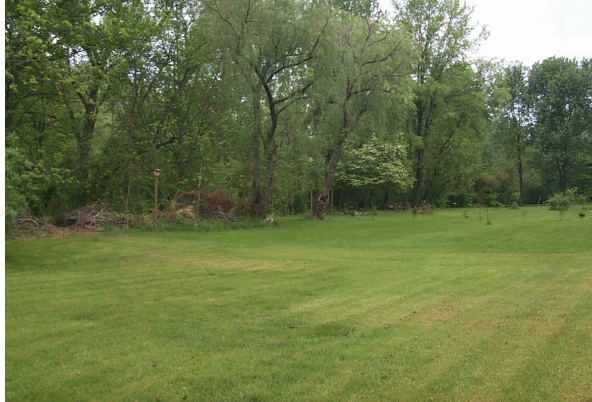
**Photo 5. Lawn mowing within public land along Gum Springs tributary**

There are two areas in the Paint Branch SPA (Gum Springs and upper Left Fork) where encroachment by private property owners into public lands that run along the stream corridor is impacting the quality of stream condition. Along sections of both the Gum Springs tributary and the Left Fork, residents are mowing the flood plain and piling lawn debris and trash along stream banks, thus inhibiting the growth of beneficial stream side vegetation (photos 5 thru 8). Reforestation and prevention of encroachment and dumping would greatly improve the situation in these areas. DEP will consult with M-NCPPC to identify how to best handle these issues.

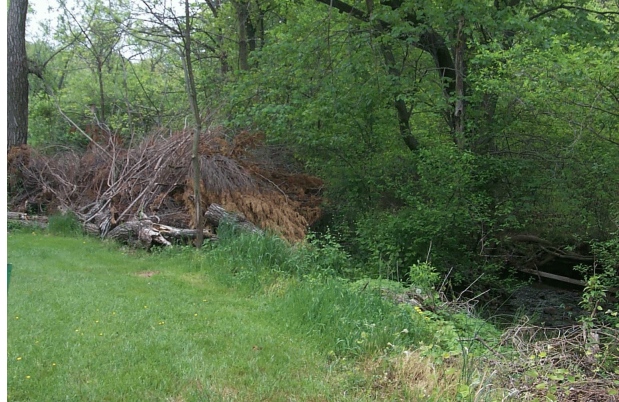
**Photo 6. Lawn debris piled along banks of Gum Springs tributary**

stream is in public ownership, area landowners are in the habit of mowing to the banks of the streams and dumping yard waste and trash on the banks (photos 7 and 8).

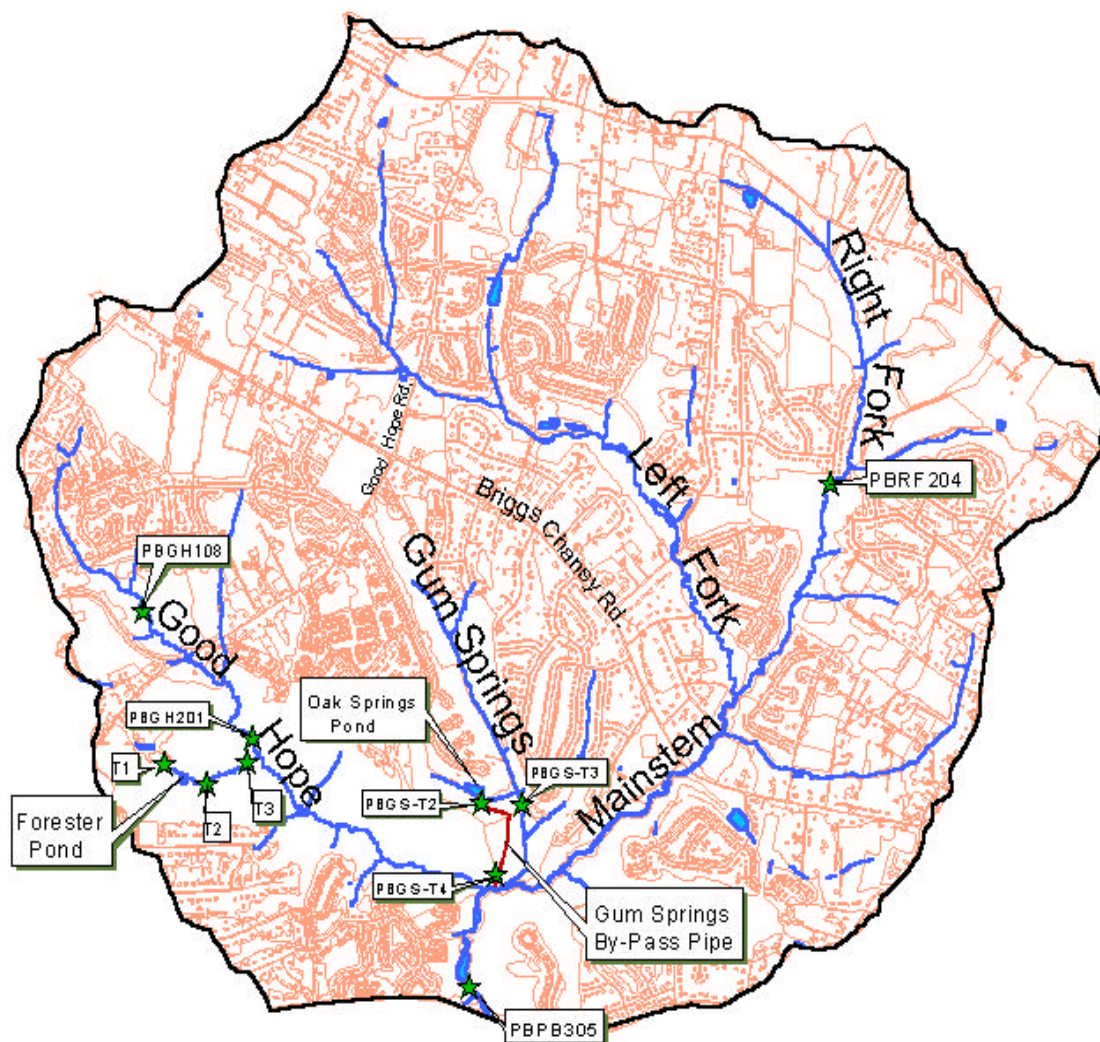
Continuous temperature loggers were deployed at ten stations in Paint Branch SPA during the summer of 2000 (Figure 39). There were three loggers placed in the Gum Springs watershed and 5 loggers placed in the Good Hope watershed. One logger was deployed in the Right Fork. One logger was deployed in the Mainstem.

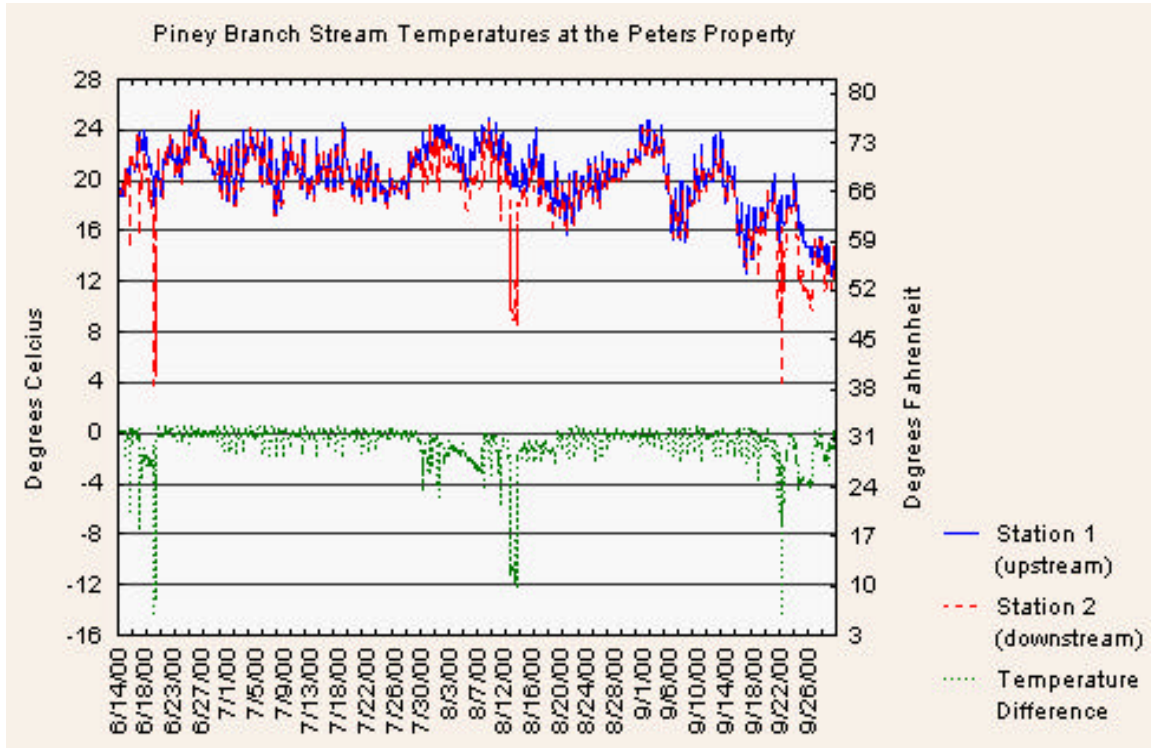
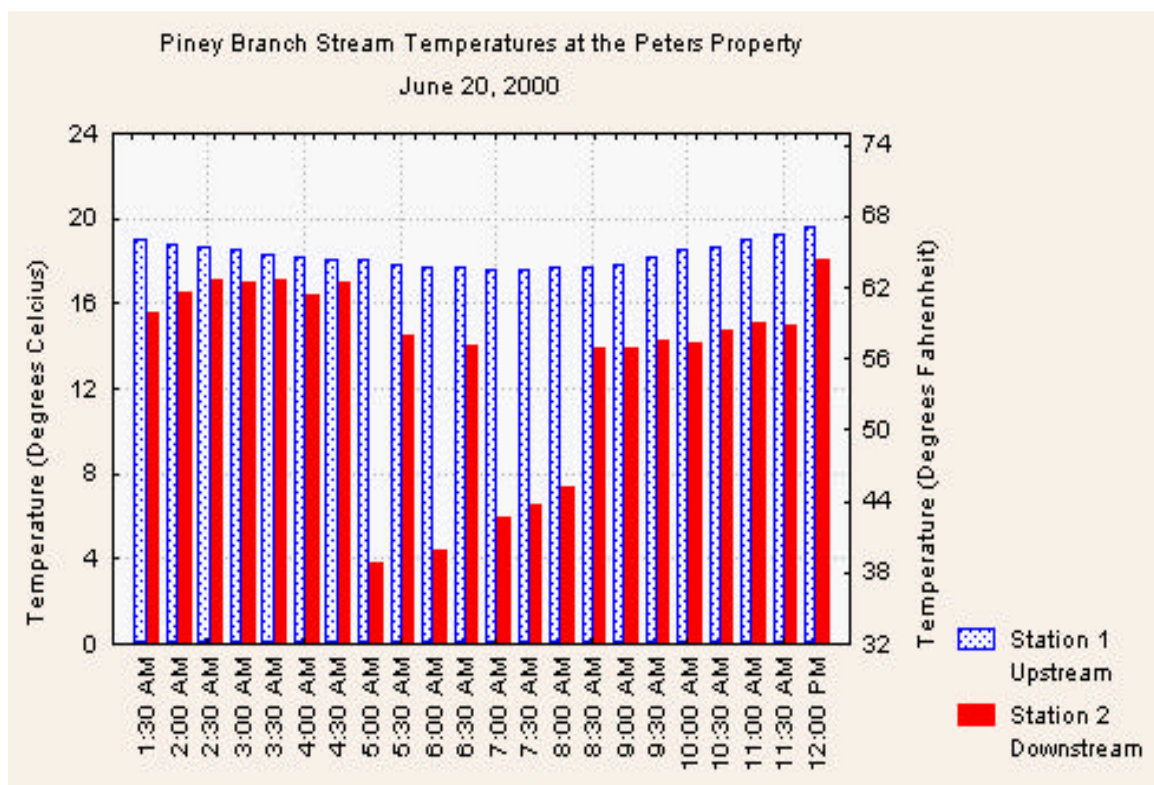
Temperature data collected by the developer's consultant at this site in 2000 is suspect. Figures 48 and 49 are graphs of temperature data from the site. The data shows unlikely values and wide fluctuations at the downstream temperature logger. For example, on the morning of June 20, 2000 the upstream logger showed little change in stream temperature, averaging 64.9 °F (Figure 49). The downstream logger fluctuated rapidly between 62.60 °F and 38.82 °F. Over the summer the downstream logger indicated that stream temperatures were consistently lower there than at the upstream site. On average, the downstream readings were 1.37 °F degrees lower than upstream. A maximum difference of 25.62 °F was seen between the upstream and downstream loggers at the site. This pattern of fluctuating temperatures downstream that are generally quite a bit cooler than temperatures upstream indicates that the logger was not working properly. Evaluation of the temperature effects of the site cannot properly be done until further data has been received.

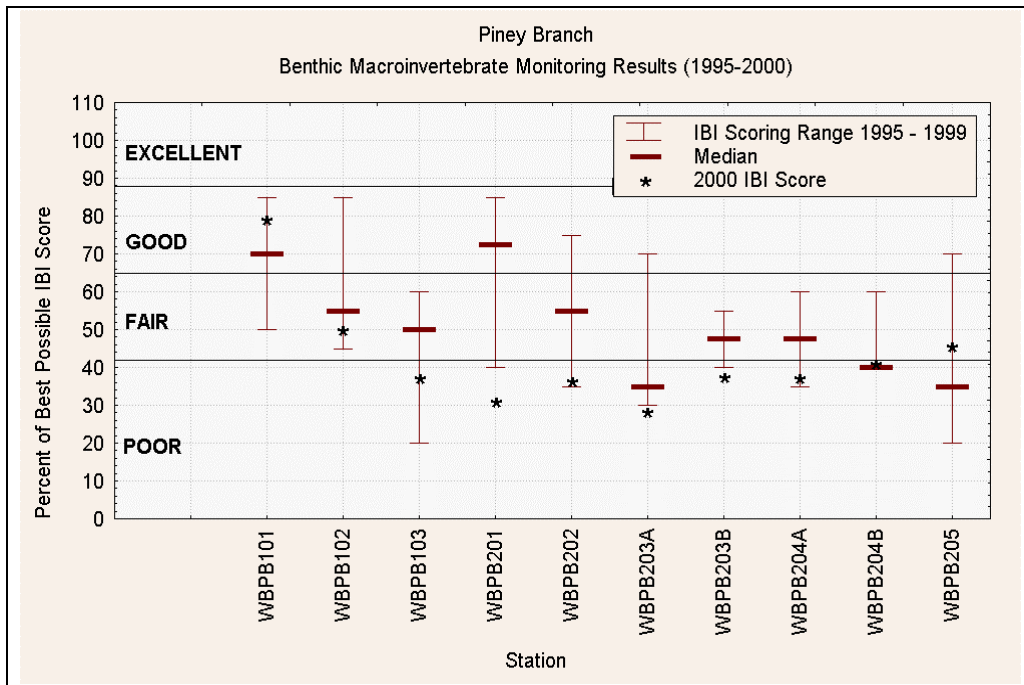
Results of benthic macroinvertebrate monitoring from 2000 are presented in Figure 55. As can be seen in the graph, benthic macroinvertebrates continue, for a second year, to indicate that a shift to a more pollution tolerant community has occurred throughout the mainstem of Piney Branch. Results from the Western Tributary (WBPB101) indicate no such shift has occurred there. The Western Tributary is subject to essentially the same weather and hydrological conditions as the rest of the watershed. However, no development has occurred in this sub-watershed. The continued presence of high quality biological communities in the Western Tributary tends to rule out natural stressors (ie. drought or flooding) as the major cause of impairment throughout the rest of Piney Branch Watershed.
